# **Macrophyte Evaluation 2008**

## **Rich Passage Beach Nourishment**

October 31, 2008

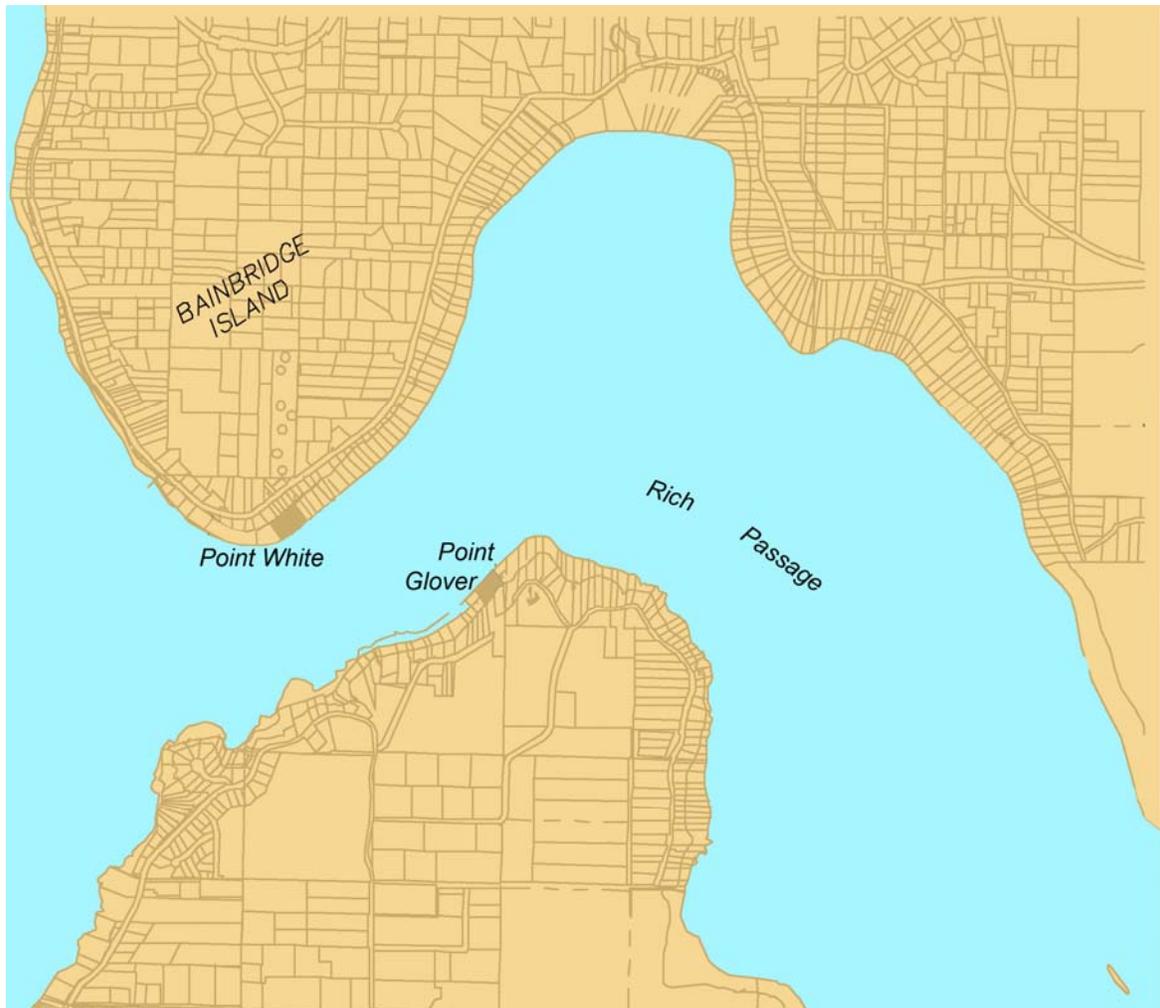
**Figure 1. Macrophyte monitoring sites for beach nourishment action.**

Evaluation of the macrophyte communities is being conducted at each of the two proposed beach nourishment locations (Figure 1):

- Point White East (north side Rich Passage)
- Glover Point (south side Rich Passage)

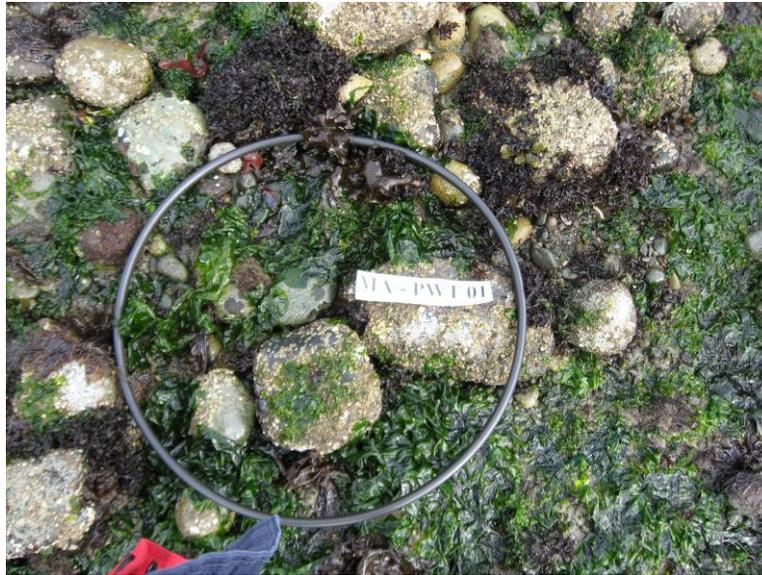
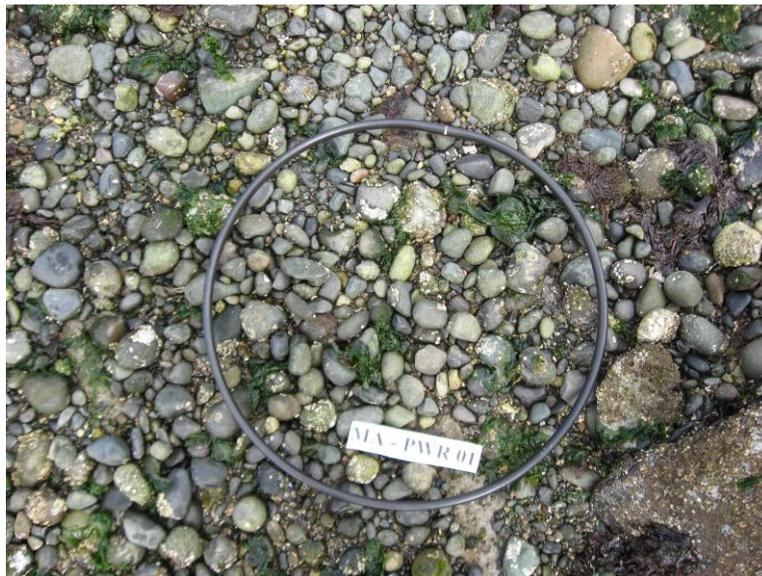
**Figure 2. Top photo: Pt. White Treatment, large substrate and high algal cover. Bottom photo: Point White Reference, small substrate and low algal cover.**

At Point White, the difference in percent cover between the treatment and reference locations was likely due to the larger, less mobile cobbles present on the surface at the treatment location apparently due to a higher energy environment (Figure 2). At Point Glover, the reference location appeared to be effectively “higher” in elevation because the substrate had fewer small crevices and topographic low points that held water at higher tides (Figure 3).

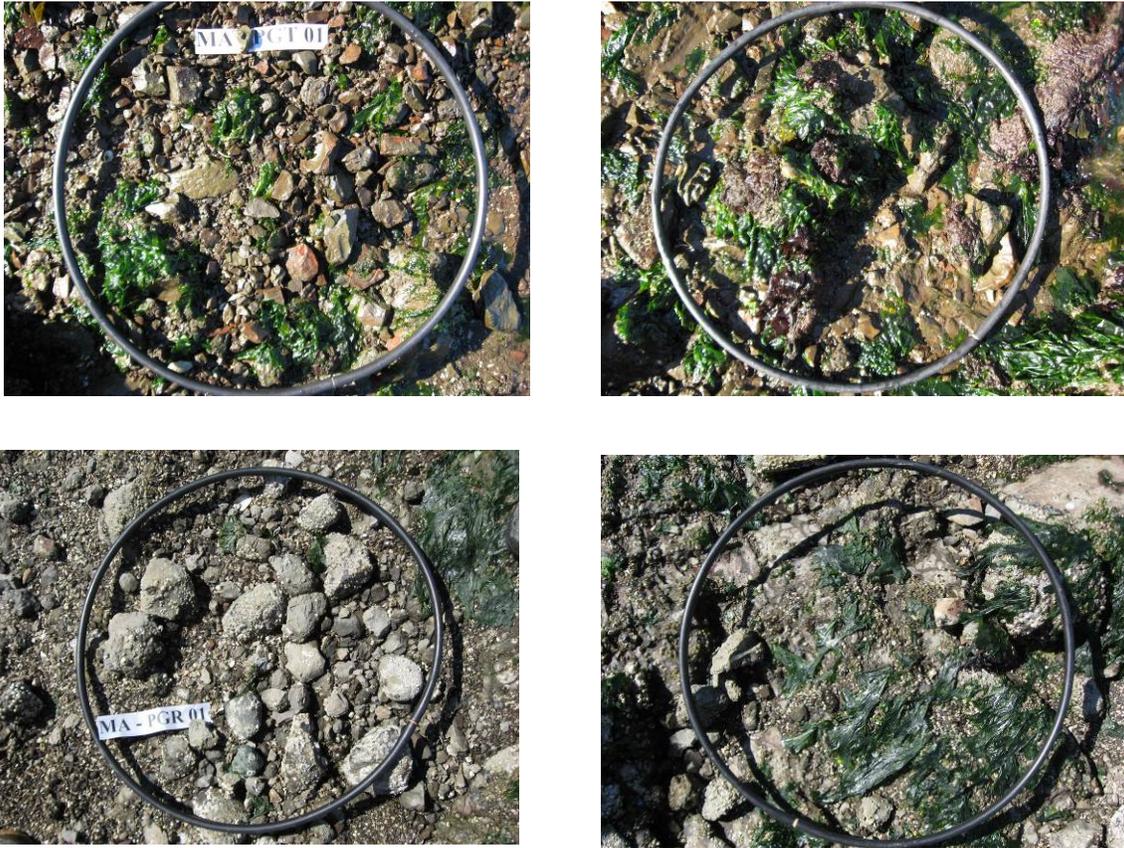
**Figure 3. Top photos: Pt Glover treatment, hard clay substrate with embedded cobbles and more attached algae. Bottom photos: Pt. Glover reference, loose cobbles with less algae.**

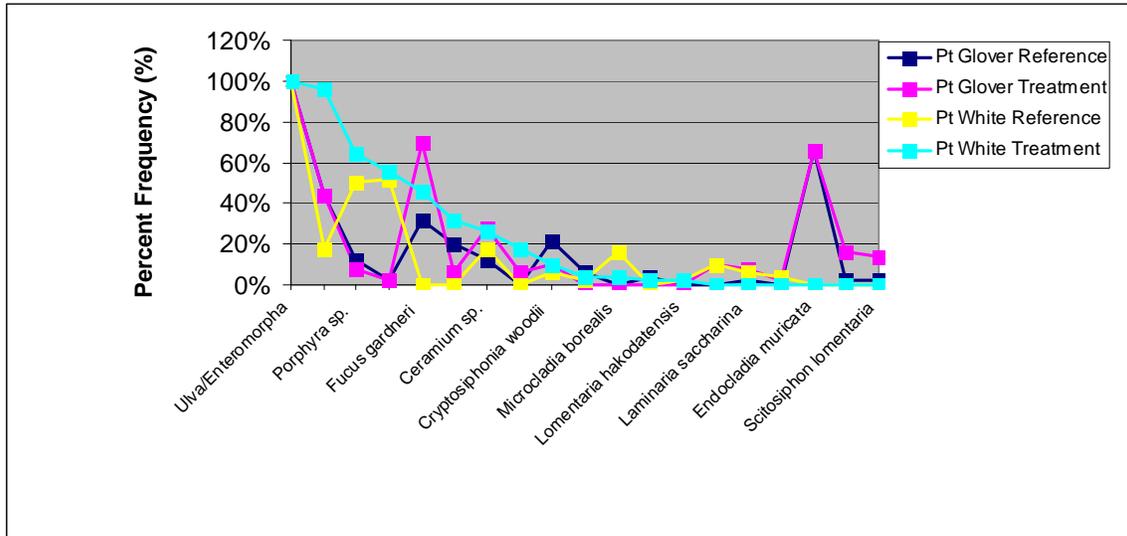
Figure 4. Percent frequency of macrophyte taxa observed in quadrats at Pt. Glover and Pt. White.

Figure 4 graphically portrays the relative frequency of occurrence of the various taxa at each treatment and reference location. Several species that were present at only one location were relatively abundant at these locations. For example, at Point White *Mazzella* sp. was present only at the treatment location but was abundant there (18% frequency). *Fucus gardneri* was also present only at the Point White treatment location and occurred in 46% of the quadrat samples.
